GPR AS A TOOL FOR DETECTING PROBLEMS IN HIGHWAY-RELATED CONSTRUCTION AND MAINTENANCE

J. Scott Lewis*, William P. Owen+, and Charles Narwold+

California Department of Transportation,

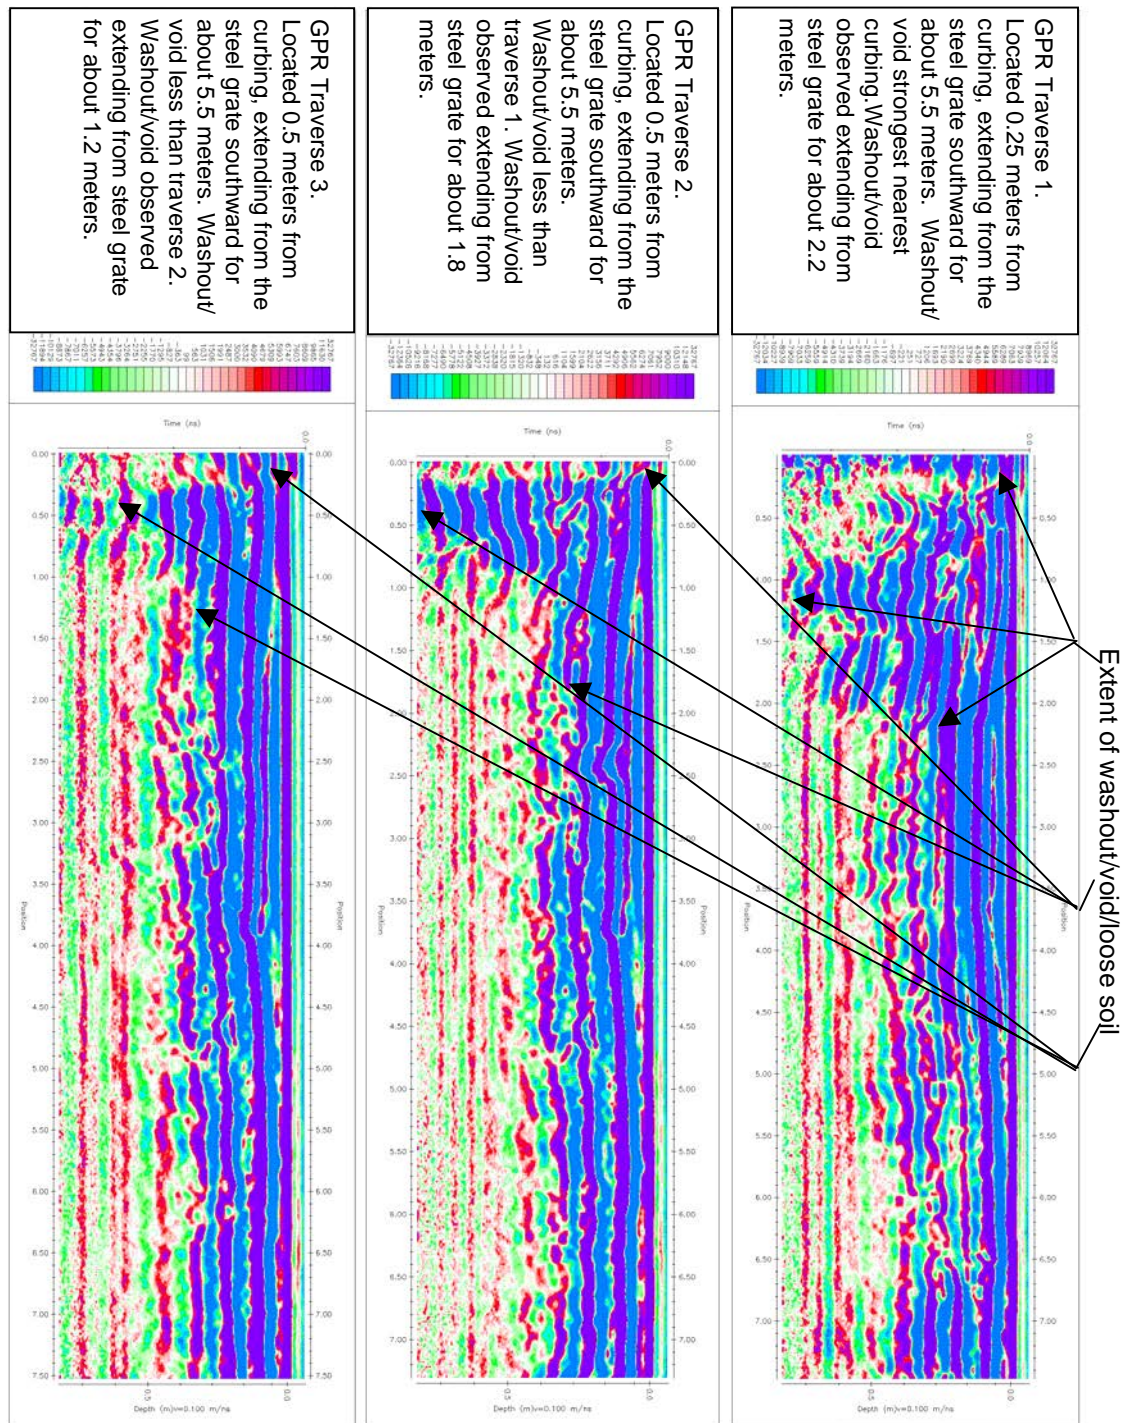
Figure 2 shows the first 7.5 meters of the 900 MHz North-South profiles 1, 2, and 3, which were obtained parallel to the curbing, on the asphalt, and centered approximately 0.25, 0.45, and 0.65 meters from the curbing. Washout is evident from the steel grate to about 2.2 meters on profile 1, with profiles 2 and 3 showing a decreasing extent (1.8 and 1.4 meters) of void/washout/loose soil. This is the disturbed area noticed by maintenance the previous year while working with the steel grate. Based on these radar profiles, the disturbance does not appear to continue further than about 2.2 meters south of the steel grate. It also appears to be more significant closer to the curbing, with profile 4 (1 meter from curbing) not showing any significant disturbance.

The presence of void space beneath the pavement, apparently produced by leakage from an old north-south sewage conduit, is confined to an area from 0.0 to 2.5 meters south of the steel grate that extends from just below the lip of the curb to almost 1 meter from the curb. No evidence of leakage-

Figure 2. Initial portions of GPR traverses 1,2, and 3, each extending southward from the steel grate for about 7.5 meters. Traverse 1, 2, and 3 are located about 0.25, 0.45 and 0.65 meters from the curbing, respectively.

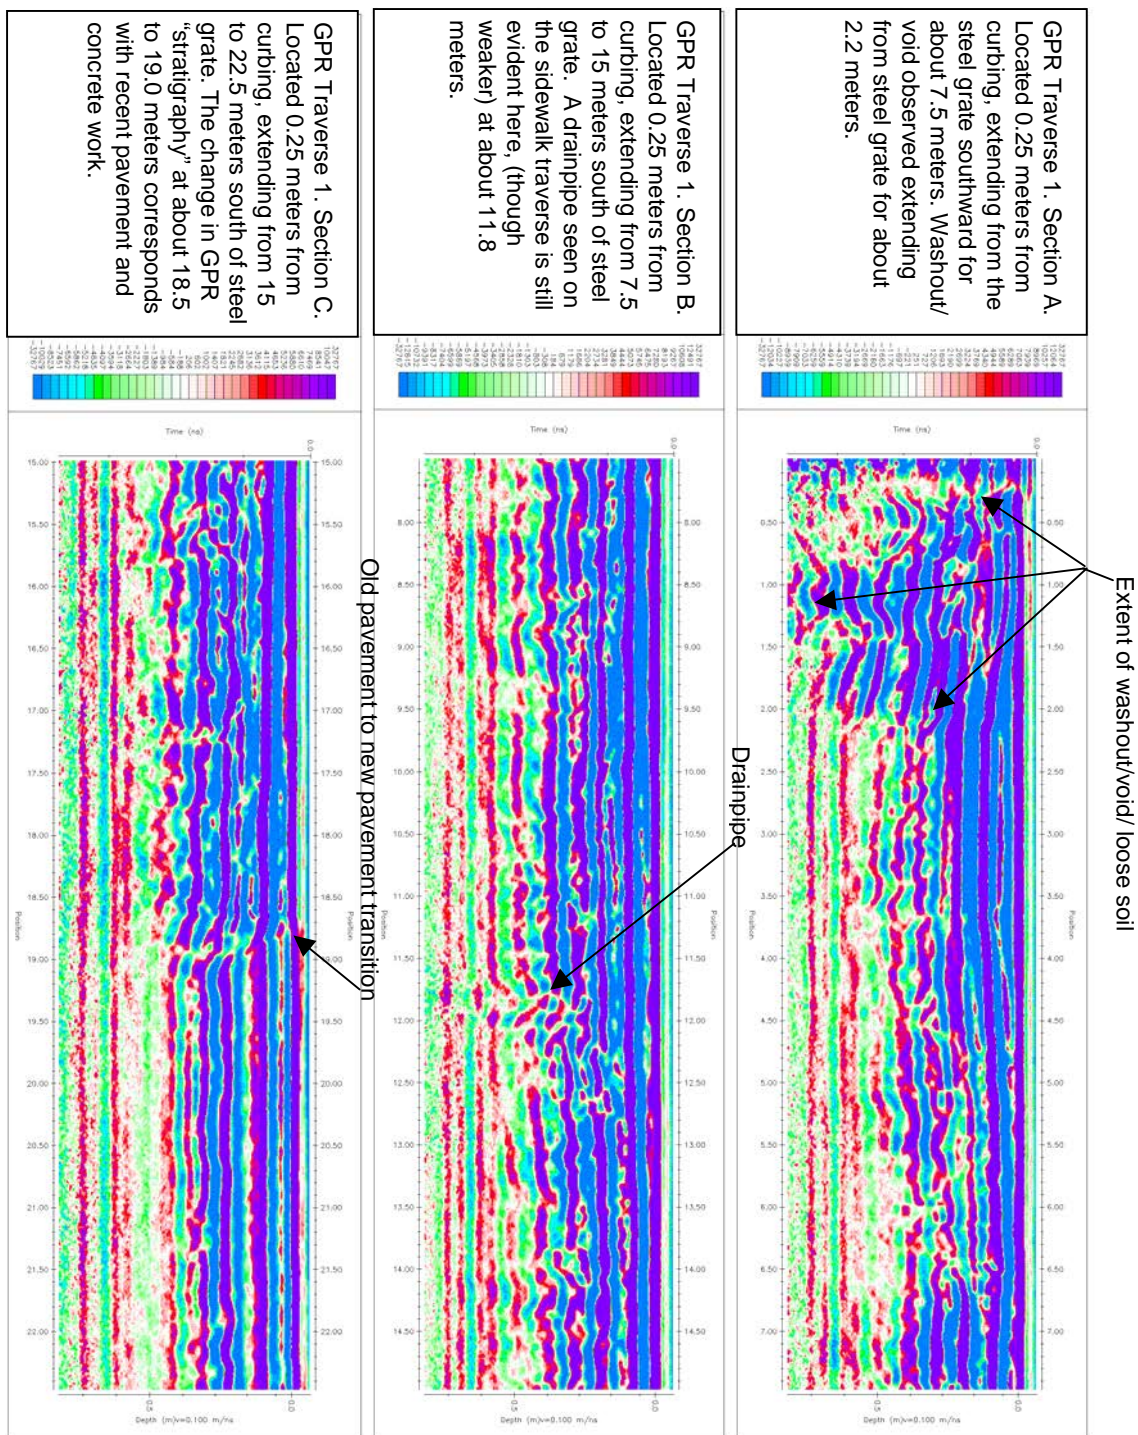
Figure 3 shows the first 22.5 meters of the 900 MHz North-South profile 1, split into three sections: section A, from 0 to 7.5 meters, section B from 7.5 to 15 meters, and section C from 15 to 22.5 meters. This profile shows several features, including the disturbed area already demonstrated in figure 2. It does not show a brick-lined sewer, however, even though the line would later be discerned with GPR precisely in the location of this profile. Its absence, of course, is due to its orientation being parallel with the traverse, rather than perpendicular (which is the best orientation for observing linear objects like pipes and conduits). A subsurface, non-metallic (not seen by a metal detector) drainpipe leading from the church (to the west) into the street, however, is evident on this profile at 11.5 to 12.0 meters because its orientation is perpendicular to the GPR traverse. Its complete absence on profile 3 and 4 indicates that it terminates. Its termination is presumed to be in the north-south brick-lined sewer running parallel to the curbing. The noticeable change in radar stratigraphy at about 18.5 to 19.0 meters on profile 1 corresponds precisely with recent pavement and concrete work associated with the driveway there.

Figure 3. GPR traverse 1 from the steel grate (0.0) to 22.5 meters, in three sections: section A from 0.0 to 7.5 meters, Section B from 7.5 to 15 meters, and section C from 15 to 22.5 meters.

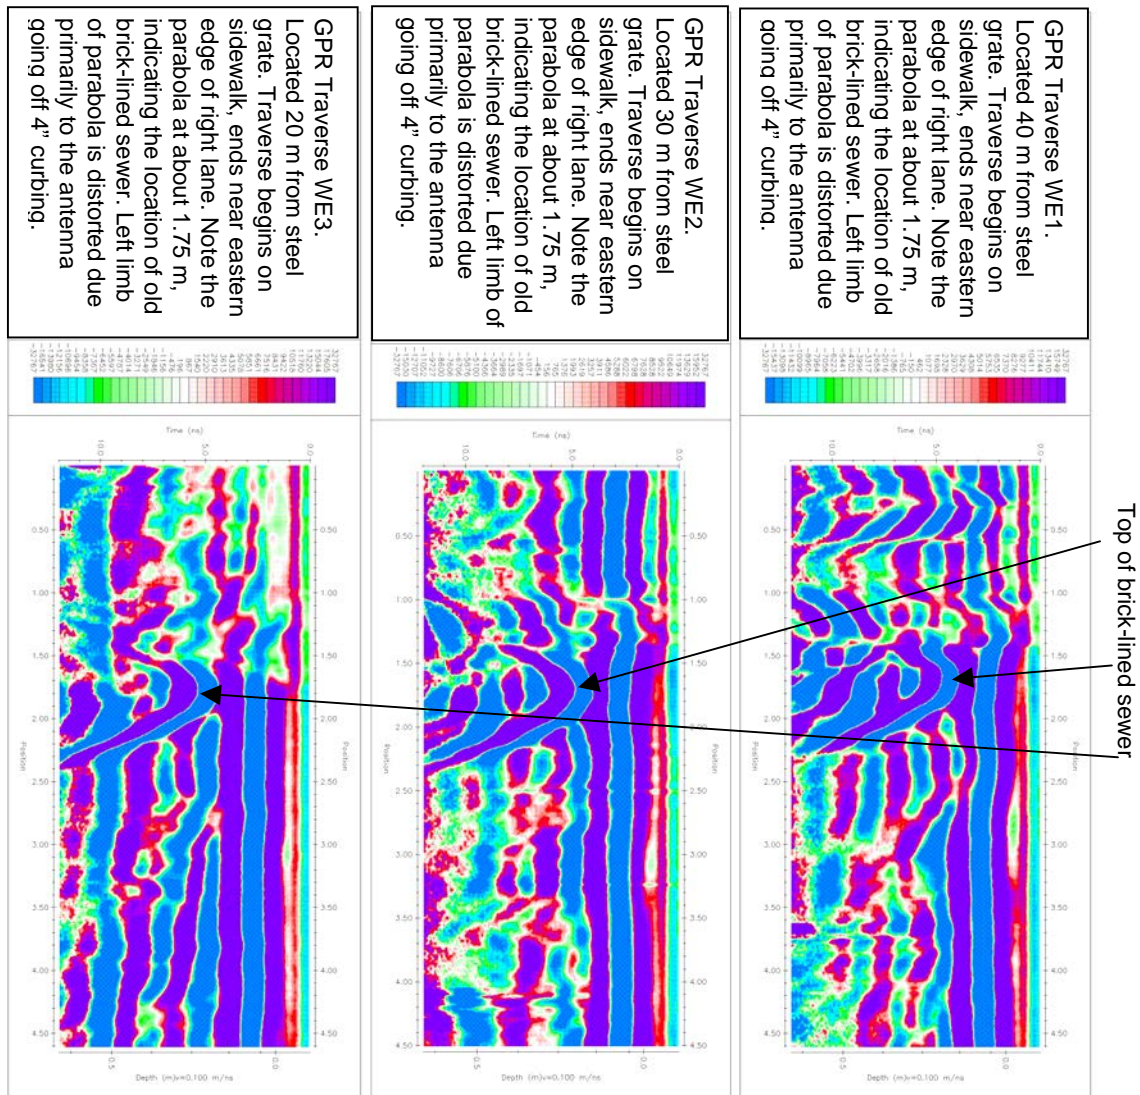
Semi-hyperbolic anomalies in the West-East profiles delineate the location of the north-south sewer beneath the pavement. These anomalies indicate the sewer is located beneath the gutter about 0.6 meters from the curbing. These profiles indicate that the top of the sewer conduit lies at a depth of about 0.3 meters below the pavement surface. Washout of subgrade material or the existence of voids is not evident in these profiles.

Figure 4 shows three of these West-East profiles and the parabolic anomalies indicative of the sewer conduit. The left limbs of these parabolas are very flat or absent, which indicates that the conduit here may be rectangular or box-shaped in cross-section, not circular. In addition, this lack of a left limb is probably related to the extra cement of the sidewalk and the transition from sidewalk to asphalt over a 4 inch curbing that is situated just about where the left limb should be on the radar profile.

Figure 4. West to east GPR traverses 1, 2, & 3 running from atop the sidewalk to the eastern side of the right lane. Traverse 1, 2, & 3 are located 40, 30, & 20 meters from the steel grate. Arrows indicate the location of the top of the old brick-lined sewer. Depth of sewer on these cross-sections is not precise due to the inability of the software to utilize more than one velocity for the subsurface.

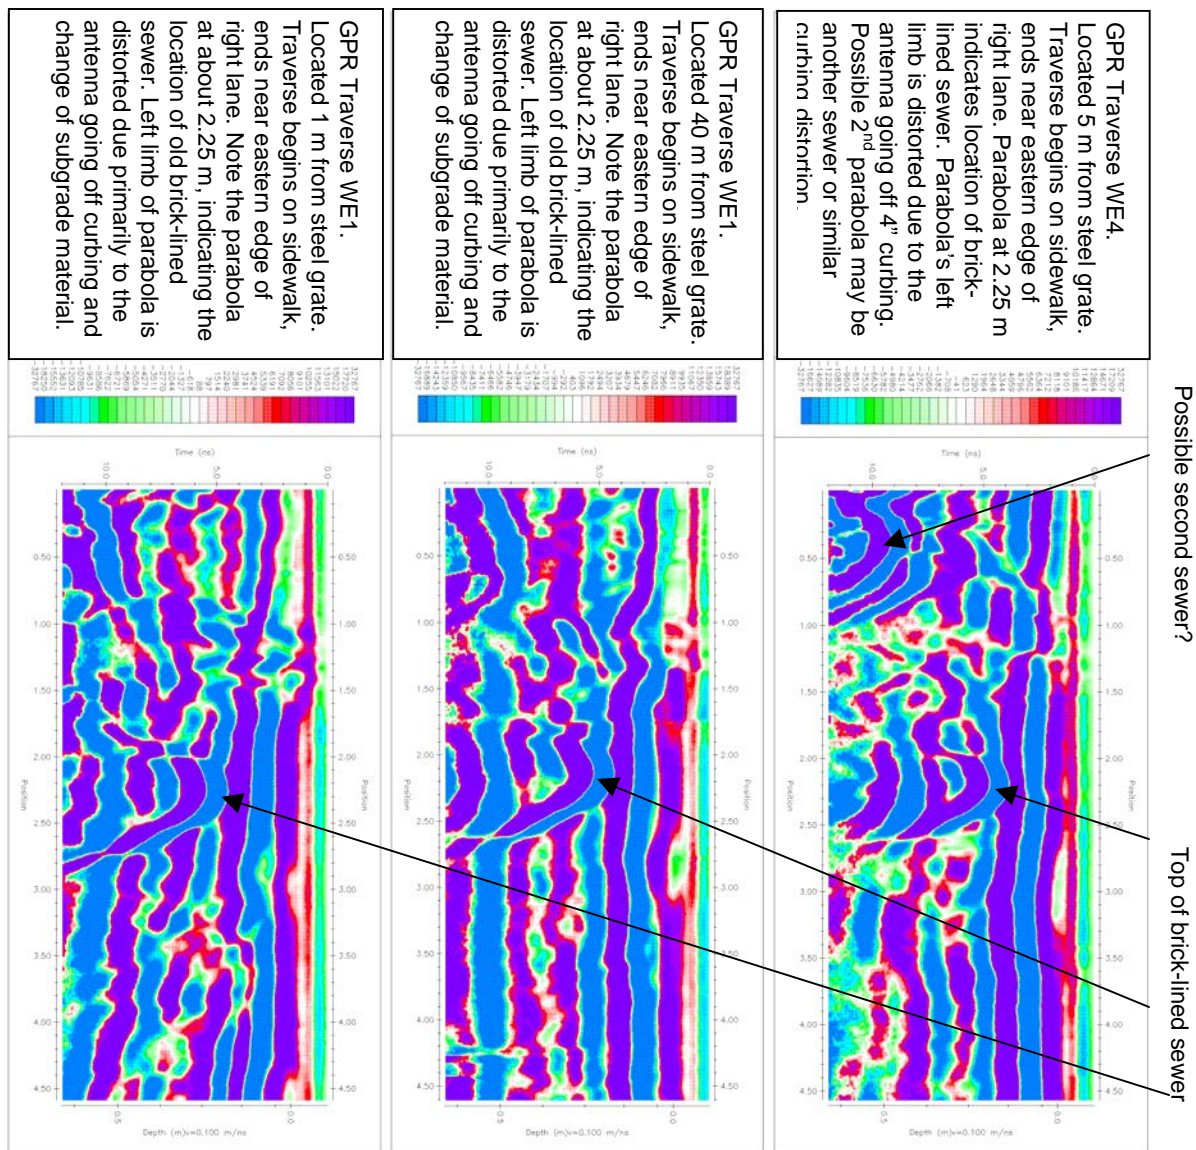
Figure 5. West to east GPR traverses 4, 5, & 6 running from atop the sidewalk to the eastern side of the right lane. Traverse 4, 5, & 6 are located 5, 2, & 1 meters from the steel grate. Arrows indicate the location of the top of the old brick-lined sewer and a possible additional sewer observed on traverse 4. Depth of sewer on these cross-sections is not precise due to the inability of the software to utilize more than one velocity for the subsurface.

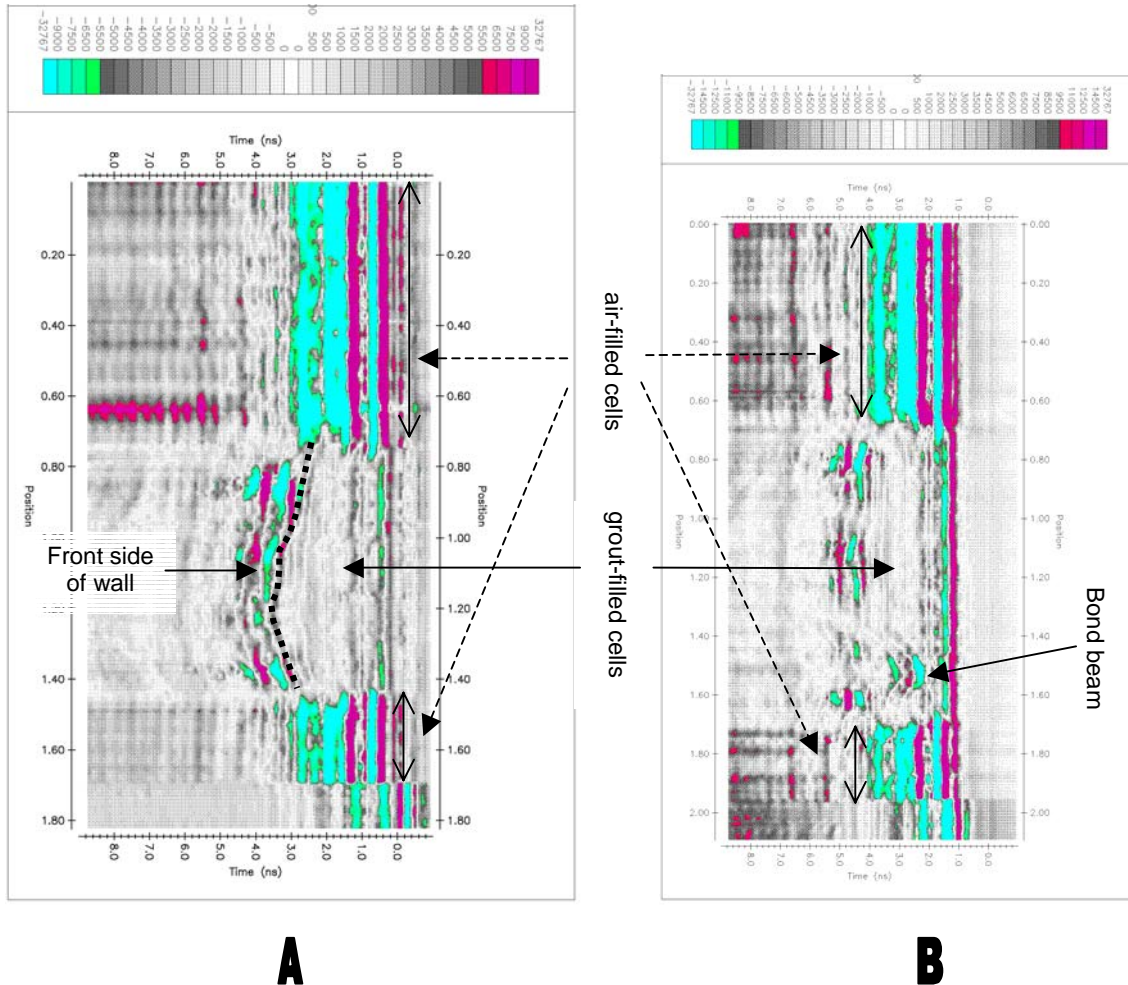
Figure 6. (A) Grout-filled cells adjacent to empty (air-filled) cells, no bond beam present. (B) Adjacent profile showing presence of bond beam within the grouted area. Reflection noted at later time in the grout-filled area is from the block/air interface at the front (freeway side) of the wall. Irregularity in that reflection is caused by architectural facing. “Ringing” in the record at late time is an artifact of the deconvolution filter applied to the data.

A similar resolution and masking problem occurred behind the #19 - #22-sized vertical reinforcing bars, where the #16-rebar bond beam and grout-filled cells could not be easily recognized. This became apparent during the first day’s survey; consequently, subsequent efforts to locate the bond beam focused on the empty (free of vertical rebar) cells. Bond beam detection was critically dependent on antenna orientation, with an antenna orientation perpendicular to the rebar axis maximizing detection. For the vertical reinforcement bars, orientation was less critical, although an orientation parallel to the rebar axis was found to produce the best lateral resolution. Figure 6-A shows grout-filled cells without rebar next to empty, air-filled cells on either side. No bond beam signature was apparent. Figure 6-B, recorded in the

same direction and approximately 1.5 meters away from 6A, shows grout-filled cells, again adjacent to air-filled cells. Here, however, a bond beam can be clearly seen running through the grouted cells. The results showed the amount of emplaced grout for the bond beam exceed specifications, as well as a missing bond beam in one location (figure 6A).

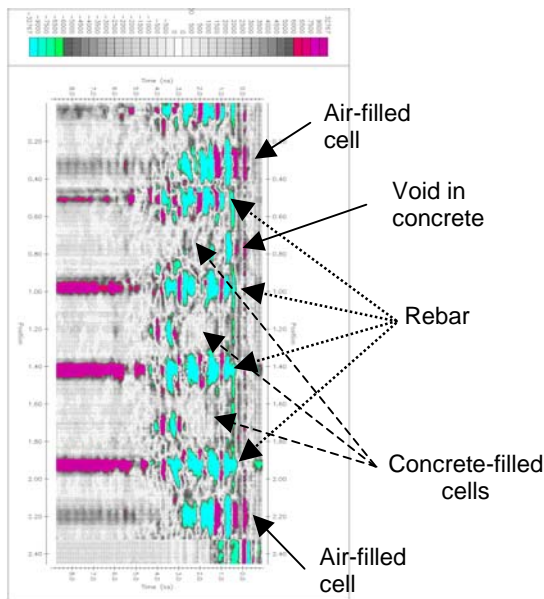
GPR also successfully located the vertical reinforcement bars and determined which cells were empty (air-filled). This was achieved through careful observation of polarity reversals between reinforced cells (very high conductivity) and air-filled cells (very low conductivity). The location of rebar was independently confirmed with a metal detector, though the metal detector is not capable of the detailed resolution of GPR, nor can it distinguish between air-filled and grout-filled cells absent rebar. Zones of excess concrete were located and missing bond beam segments were detected. In addition, two potential voids in the concrete (figure 7) and an anomalous rebar signature were found.

Figure 7. Grout-filled cells next to rebar. A possible void (indicated) is seen as a bleb in the otherwise reflection-free grout. Reflections visible at later time in the grouted cells are from the block/air interface at the front (freeway side) of the wall. "Ringing" in the record is an artifact of the deconvolution filter applied to the data.

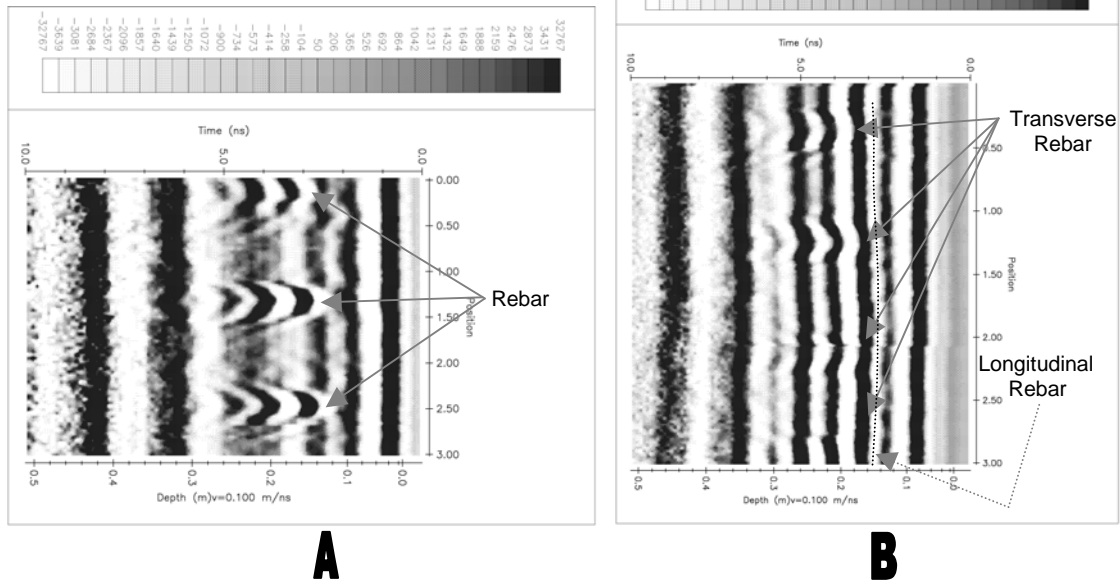
The survey lines obtained with the 1200 MHz antenna have an investigation depth of about 0.35 meters and provide good resolution of the transverse rebar of the upper mat. Transverse rebar of the upper mat appear as hyperbolic diffractions in the records (figure 8A). Some of the survey lines straddled the longitudinal rebar of the upper mat. Where this occurs, a high-amplitude continuous reflector from the longitudinal bar appears across the profile, with a

dampened reflection from the transverse rebar. This is suspected to be responsible for the difference in the amplitude of the reflections observed between adjacent survey lines (compare figure 8A vs. figure 8B from the baseline survey).

Figure 8. (A) Baseline GPR record showing transverse rebar (hyperbolas). (B) Baseline GPR record showing transverse rebar as subdued hyperbolas due to the effect of longitudinal rebar.

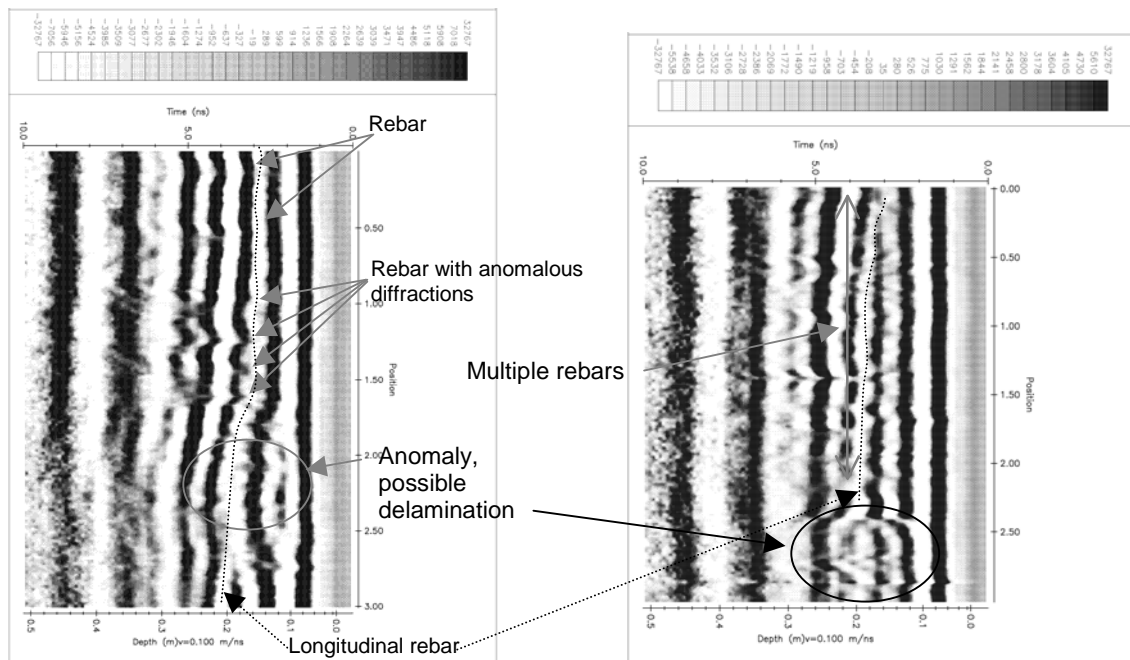
Comparison of baseline 1200 MHz reflection records to the 1200 MHz survey reflection records indicates incorrectly positioned rebar and anomalies in the vicinity of a cold joint. The depth to the top of rebar in figure 8A (baseline profile) is approximately 0.1 m and the distance between rebar is fairly consistent. The depth to the top of rebar in the actual survey records generally varies between 0.20 and 0.25 meters, and the distance between rebar is highly variable. Numerous anomalies exist in the vicinity of the cold joint and are highlighted on some of the survey records presented in figure 9. The anomalies are areas of different electrical conductivity and may represent voids or delaminations in the structure approach slab.

Figure 9. 1200 MHz GPR records showing transverse rebar (subdued by the longitudinal rebar) of the upper mat and possible construction deficiencies, including sloping uneven longitudinal rebar, anomalies, and possible delamination.
